Flood Control Project Maintenance
Levee Inspections

Fall 2013 Levee Maintenance Deficiency Summary Report

Sacramento River Basin

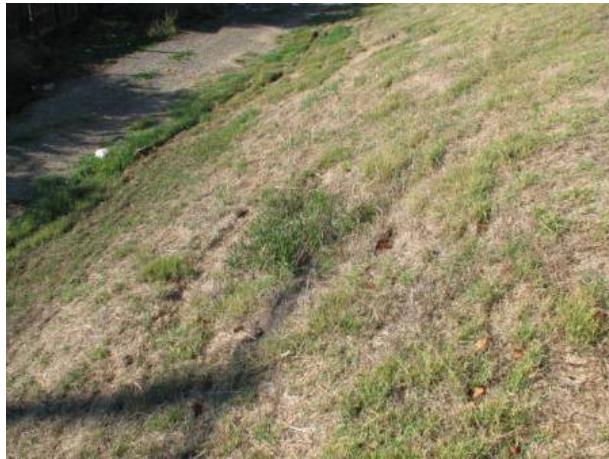
Levee Mile Report Line	5
Start Levee Mile	0.48
End Levee Mile	0.48
Location	Land Side
Category	Earthen Levee
Item	Erosion / Bank Caving
11/17/2011 Hole/depression approximately mid-slope.	
mkhashch_f_20130923_849.jpg

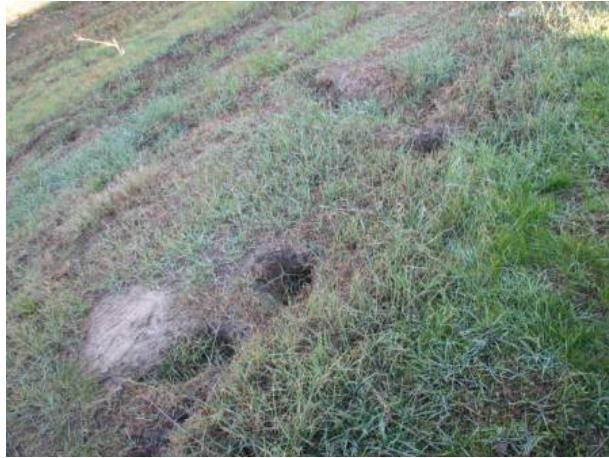
Levee Mile Report Line	6
Start Levee Mile	0.48
End Levee Mile	0.48
Location	Water Side
Category	Earthen Levee
Item	Animal Control
11/17/2011 Old rodent burrows.	
mkhashch_f_20130923_850.jpg

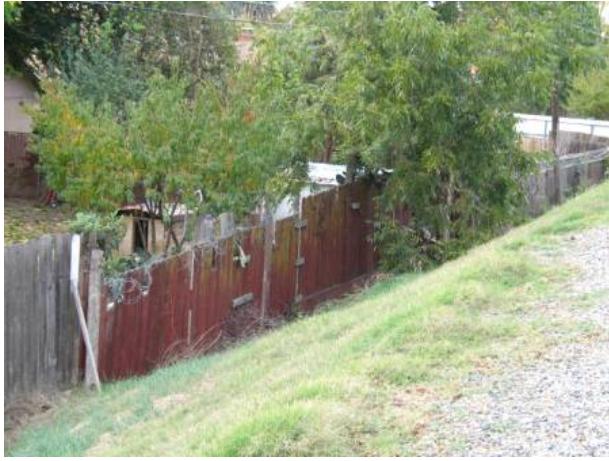
Levee Mile Report Line	12
Start Levee Mile	1.17
End Levee Mile	1.17
Location	Land Side
Category	Earthen Levee
Item	Encroachments
11/17/2011 Wooden privacy fence built at the levee toe.	
mkhashch_f_20130923_835.jpg

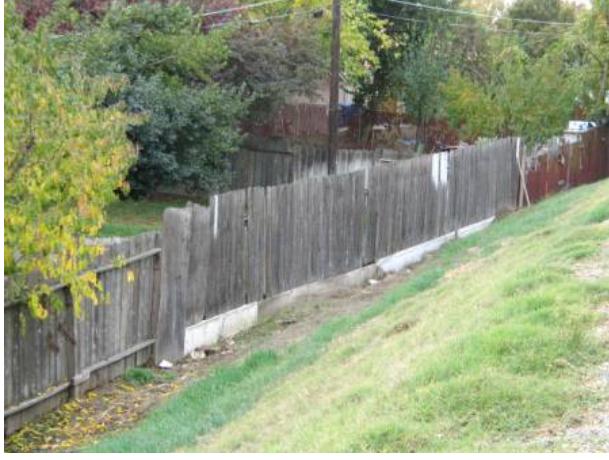
Levee Mile Report Line	13
Start Levee Mile	1.18
End Levee Mile	1.18
Location	Land Side
Category	Earthen Levee
Item	Encroachments
11/17/2011 Wooden privacy fence built at the levee toe.	
mkhashch_f_20130923_834.jpg

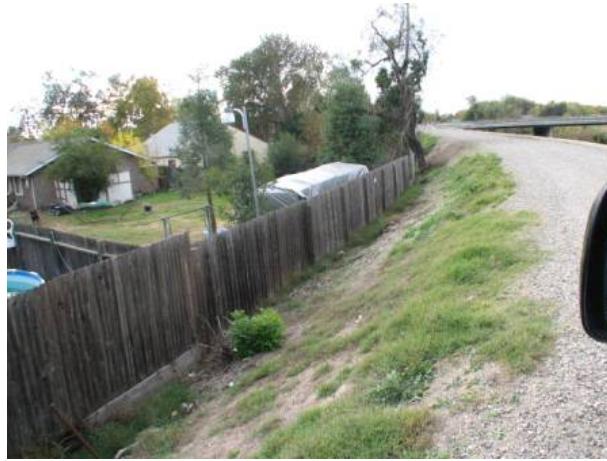
Levee Mile Report Line	19
Start Levee Mile	1.37
End Levee Mile	1.37
Location	Land Side
Category	Earthen Levee
Item	Encroachments
11/17/2011 Wooden privacy fence built at the levee toe.	
mkhashch_f_20130923_830.jpg

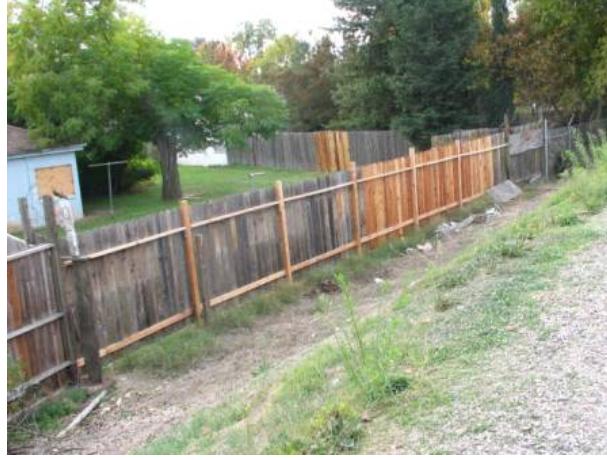
Levee Mile Report Line	23
Start Levee Mile	1.41
End Levee Mile	1.41
Location	Land Side
Category	Earthen Levee
Item	Encroachments
11/17/2011 New wooden privacy fence built within 15' of the levee toe.	
mkhashch_f_20130923_827.jpg

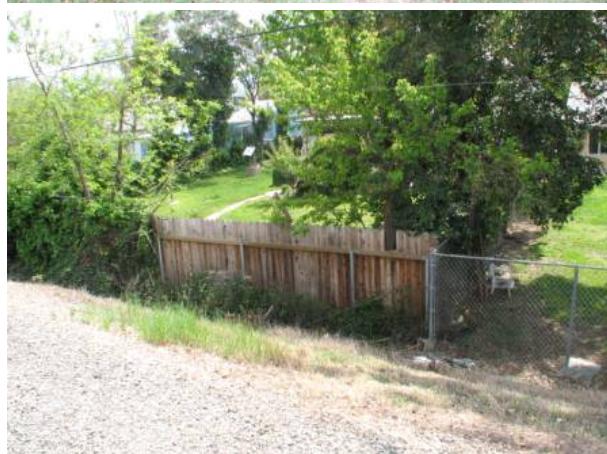
Levee Mile Report Line	38
Start Levee Mile	1.83
End Levee Mile	1.83
Location	Land Side
Category	Earthen Levee
Item	Encroachments
04/13/2011 Portion of fence has been replaced, assume that this is the portion that fell down and was referenced in the fall '10 inspection.	
mkhashch_f_20130923_824.jpg

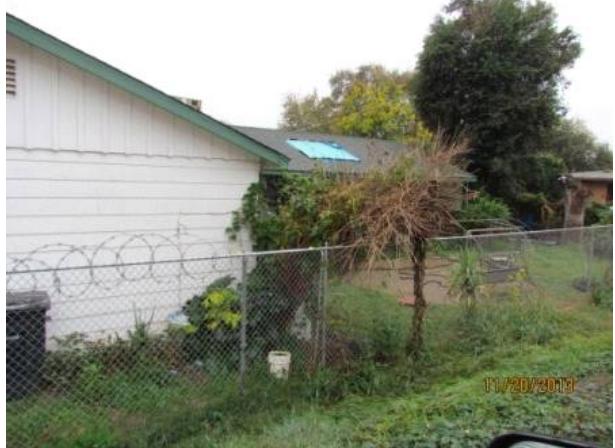
Levee Mile Report Line	48
Start Levee Mile	2.00
End Levee Mile	2.00
Location	Land Side
Category	Earthen Levee
Item	Vegetation
View of the fence and landscaping at the landside levee toe.

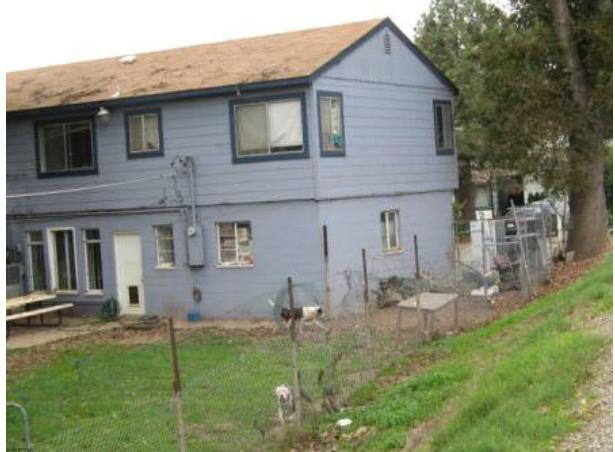
Levee Mile Report Line	49
Start Levee Mile	2.02
End Levee Mile	2.02
Location	Land Side
Category	Earthen Levee
Item	Encroachments
11/17/2011 Building foundation is within 15' of the levee toe.

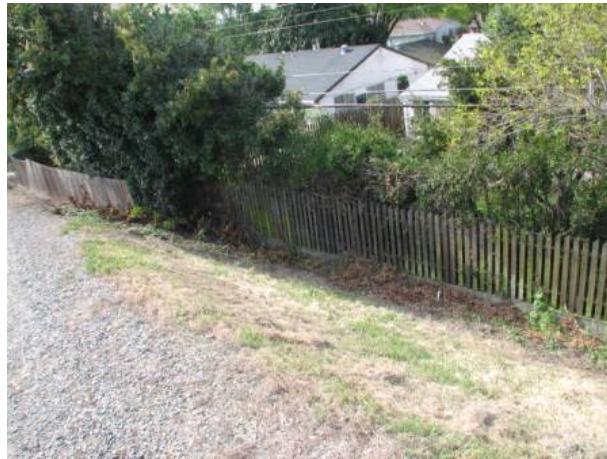
Levee Mile Report Line	20
Start Levee Mile	3.91
End Levee Mile	3.91
Location	Land Side
Category	Earthen Levee
Item	Encroachments
03/16/2012 Wood privacy fence completely obstructs access and visibility.	
mkhashch_f_20130923_881.jpg

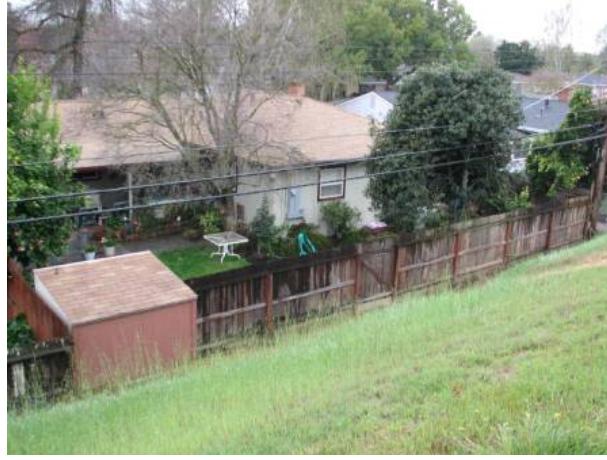
Levee Mile Report Line	32
Start Levee Mile	4.09
End Levee Mile	4.09
Location	Land Side
Category	Earthen Levee
Item	Encroachments
03/16/2012 Wood privacy fence completely obstructs access and visibility.	
mkhashch_f_20130923_892.jpg

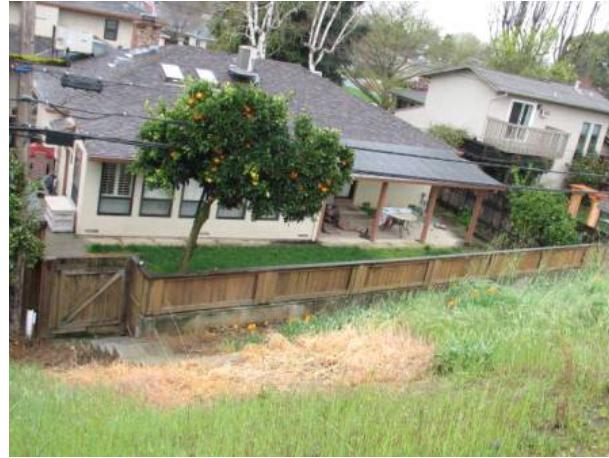
Levee Mile Report Line	35
Start Levee Mile	4.12
End Levee Mile	4.12
Location	Land Side
Category	Earthen Levee
Item	Encroachments
03/16/2012 Wooden fence on cement wall obstructs access and visibility.	
mkhashch_f_20130923_895.jpg

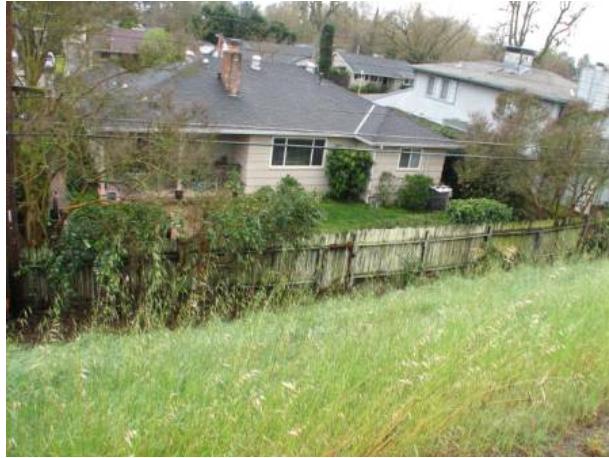
Levee Mile Report Line	51
Start Levee Mile	4.40
End Levee Mile	4.40
Location	Land Side
Category	Earthen Levee
Item	Encroachments
03/16/2012 Wood privacy fence completely obstructs access and visibility.	
mkhashch_f_20130923_043.jpg

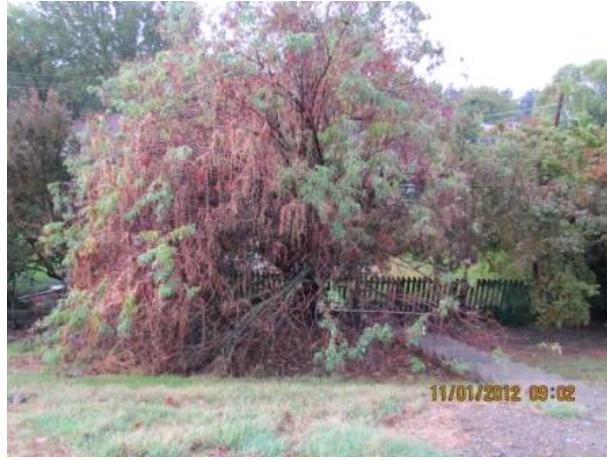
Levee Mile Report Line	55
Start Levee Mile	4.50
End Levee Mile	4.50
Location	Water Side
Category	Earthen Levee
Item	Vegetation
View of large elderberry bush obstructing visibility and access.	
mkhashch_f_20130923_060.JPG

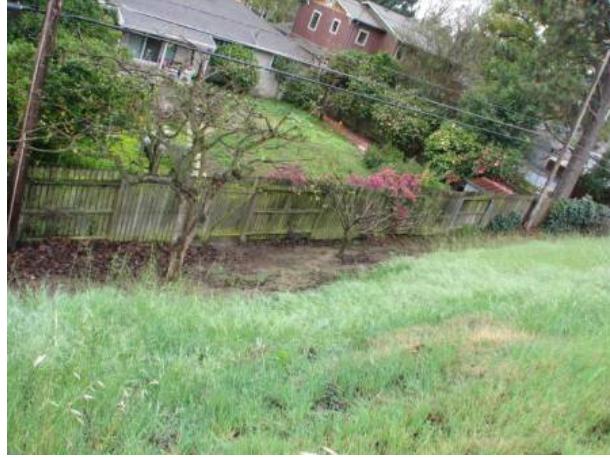
Levee Mile Report Line	59
Start Levee Mile	4.54
End Levee Mile	4.54
Location	Land Side
Category	Earthen Levee
Item	Encroachments
03/16/2012 Wood privacy fence completely obstructs access and visibility.	
mkhashch_f_20130923_045.jpg

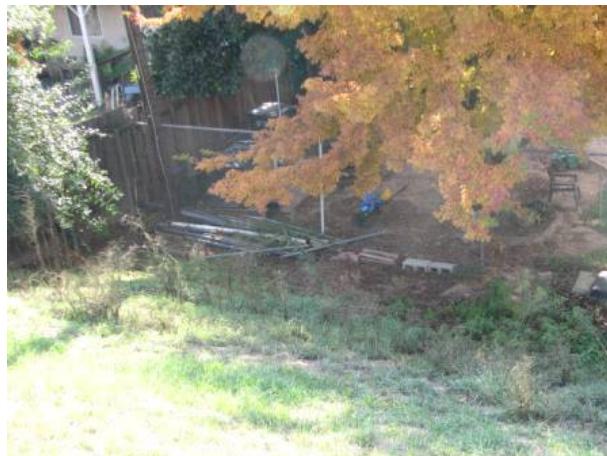
Levee Mile Report Line	66
Start Levee Mile	4.72
End Levee Mile	4.72
Location	Land Side
Category	Earthen Levee
Item	Encroachments
11/15/2011 Debris on levee side of fence. This item was noted in the USACE PI.	
mhashch_f_20130923_061.jpg

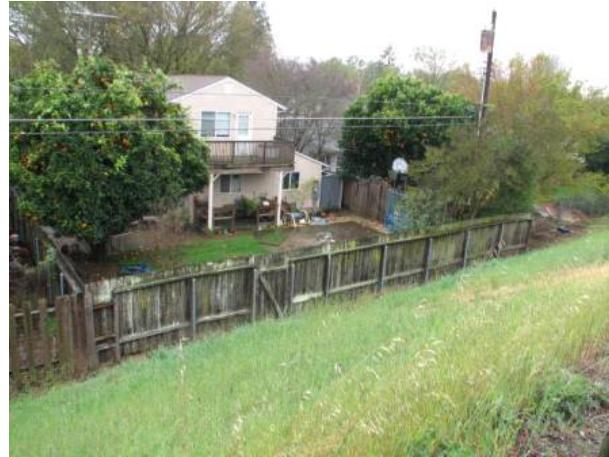
Levee Mile Report Line	67
Start Levee Mile	4.73
End Levee Mile	4.73
Location	Land Side
Category	Earthen Levee
Item	Encroachments
03/16/2012 Wood privacy fence completely obstructs access and visibility.	
mkhashch_f_20130923_904.jpg

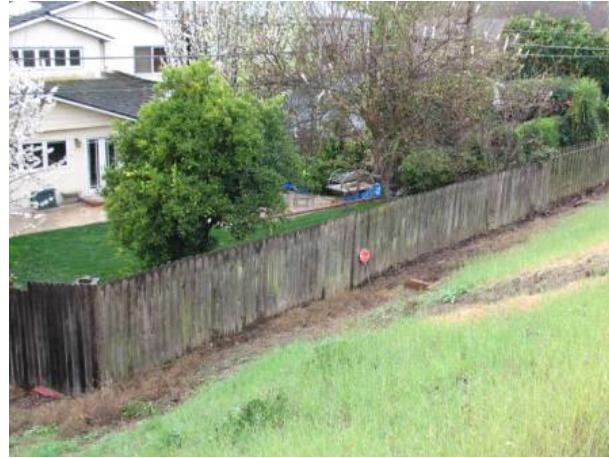
Levee Mile Report Line	69
Start Levee Mile	4.75
End Levee Mile	4.75
Location	Land Side
Category	Earthen Levee
Item	Encroachments
03/16/2012 Wood privacy fence completely obstructs access and visibility.	
mkhashch_f_20130923_905.jpg

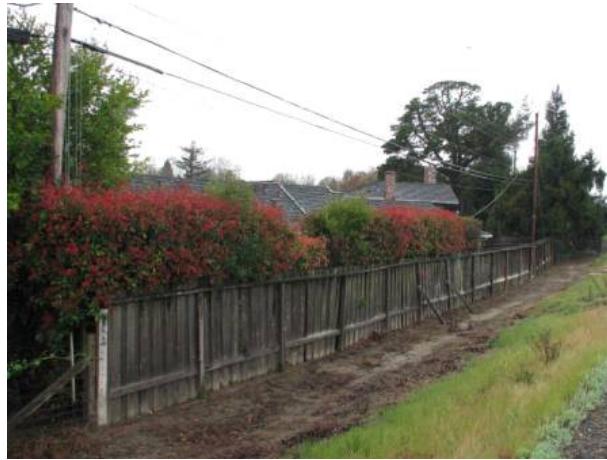
Levee Mile Report Line	77
Start Levee Mile	5.08
End Levee Mile	5.08
Location	Land Side
Category	Earthen Levee
Item	Encroachments
03/16/2012 Wood privacy fence completely obstructs access and visibility.	
mkhashch_f_20130923_908.jpg

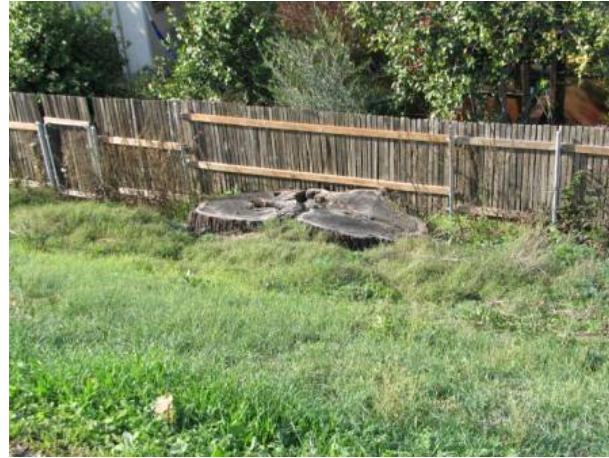
Levee Mile Report Line	105
Start Levee Mile	5.93
End Levee Mile	5.93
Location	Land Side
Category	Earthen Levee
Item	Encroachments
11/15/2011 Large stump at levee toe.	
mkhashch_f_20130923_063.jpg

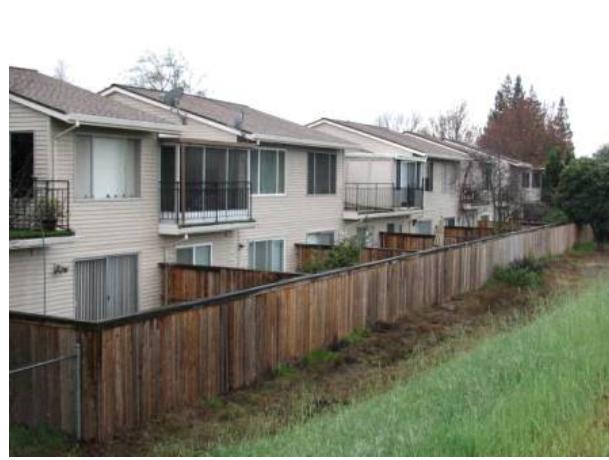
Levee Mile Report Line	123
Start Levee Mile	7.91
End Levee Mile	7.94
Location	Land Side
Category	Earthen Levee
Item	Encroachments
03/16/2012 Wood privacy fence completely obstructs access and visibility.	
mkhashch_f_20130923_933.jpg

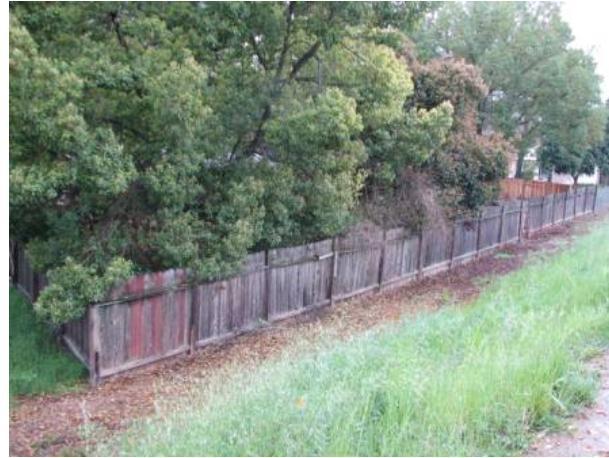
Levee Mile Report Line	148
Start Levee Mile	8.39
End Levee Mile	8.39
Location	Land Side
Category	Earthen Levee
Item	Encroachments
03/16/2012 Wood privacy fence completely obstructs access and visibility.	
mkhashch_f_20130923_955.jpg

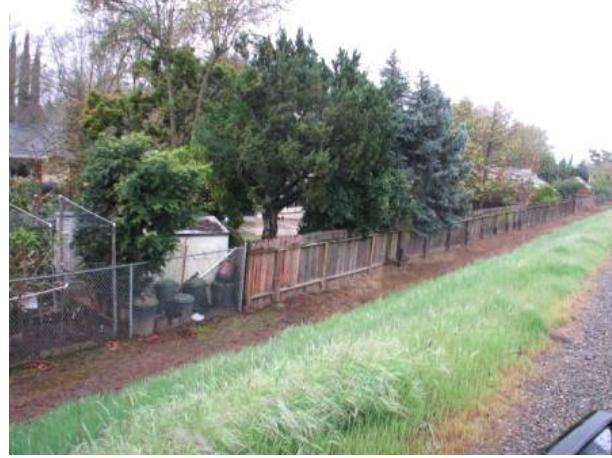
Levee Mile Report Line	167
Start Levee Mile	8.70
End Levee Mile	8.70
Location	Land Side
Category	Earthen Levee
Item	Encroachments
03/16/2012 Wood privacy fence completely obstructs access and visibility.	
mkhashch_f_20130923_973.jpg

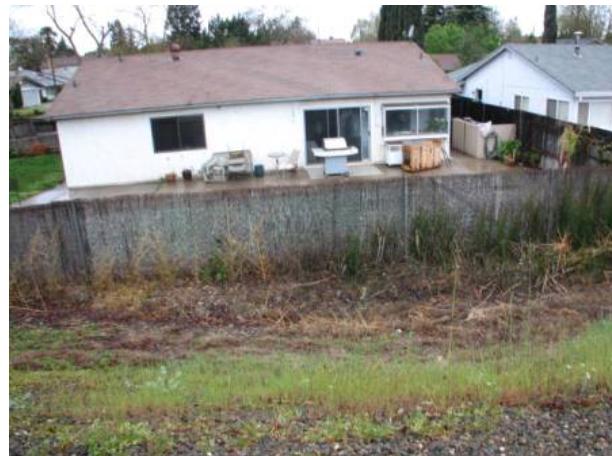
Levee Mile Report Line	218
Start Levee Mile	10.77
End Levee Mile	10.77
Location	Land Side
Category	Earthen Levee
Item	Encroachments
03/16/2012 Bamboo panels on chainlink fence completely obstruct visibility.	
mkhashch_f_20130923_031.jpg

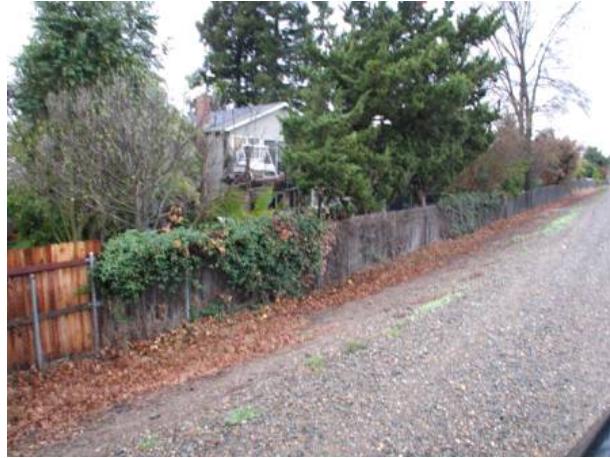
Levee Mile Report Line	227
Start Levee Mile	10.89
End Levee Mile	10.89
Location	Land Side
Category	Earthen Levee
Item	Vegetation
03/16/2012 Wood privacy fence completely obstructs access and visibility.	
mkhashch_f_20130923_019.jpg

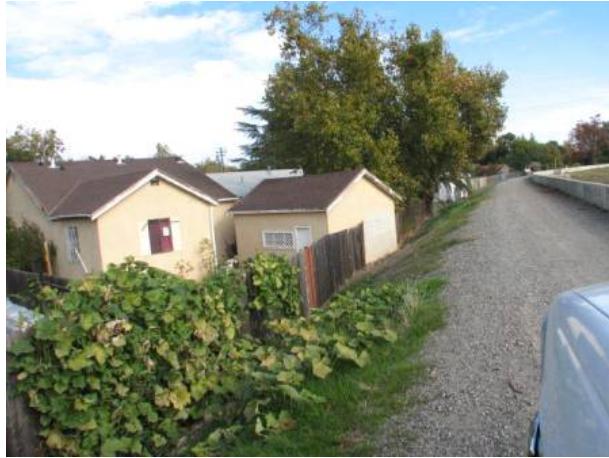
Levee Mile Report Line	20
Start Levee Mile	1.69
End Levee Mile	1.69
Location	Land Side
Category	Earthen Levee
Item	Encroachments
11/17/2011 Building is constructed at the toe.	
mkhashch_f_20130923_074.jpg

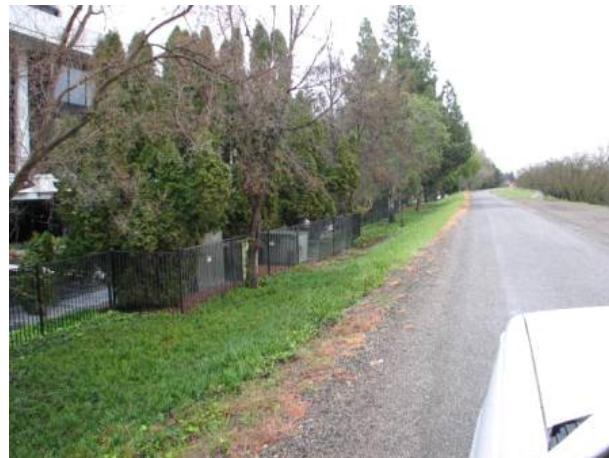
Levee Mile Report Line	8
Start Levee Mile	3.88
End Levee Mile	3.97
Location	Land Side
Category	Earthen Levee
Item	Vegetation
03/16/2012 Ivy is growing on landside slope.	
mhashch_f_20130923_114.jpg
